The use of Geographic Information System for the Assessment of Geotechnical Risks in Madagascar

Abstract - The Upper City of Antananarivo, is one of the districts of the capital of Madagascar subject to the regulations of the Architectural, Urban and Landscape Heritage Protection Zone [1]. On the other hand, the urbanization of this zone has not made it possible to curb the uncontrolled urbanization which is characterized by the spontaneity of illicit constructions caused in particular by the impoverishment of the local populations. Faced with this situation, the sanitation aspect of the area is no longer under control and all these phenomena have created a new type of exposure to risk through the degradation of the supporting soil and the triggering of fatal land movements. This urbanized area is subject to geotechnical risks that require reconnaissance on geological structuring, urbanization and problems observed to monitor the evolution of hazards. Technical studies of the Antananarivo upper town massif reveal instability and eventually hazards such as landslides, rock falls and block falls. These rapid phenomena expose local populations to new risks. As such, the consideration

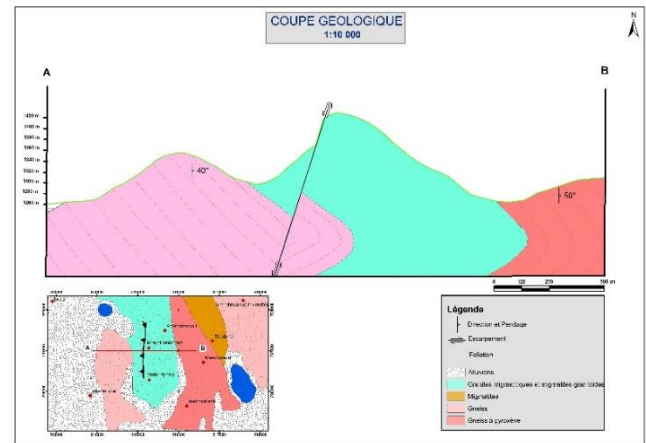
The relief of the upper town of Antananarivo is complex, consisting of the tectono-magmatic and metamorphic formation: a set of rock formations of

granite migmatite and granitoid migmatite and loose silty materials dominant on the surface.

Figure 2. Geological map of the Upper City of Antananarivo and its surroundings by GIS [7]

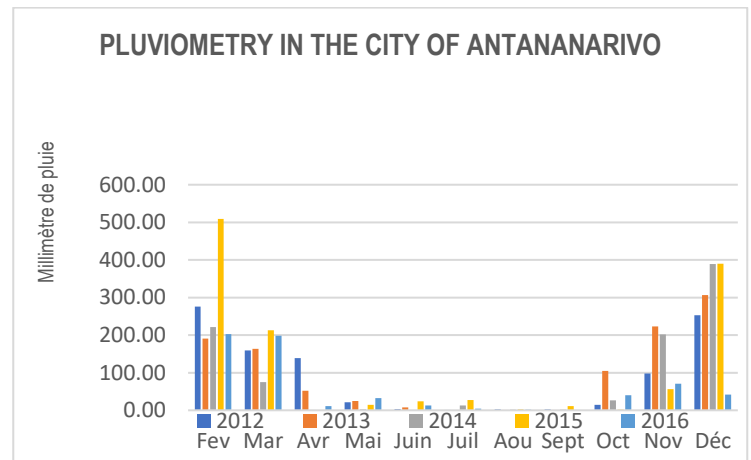
According to these established rainfall data, the average rainfall varies between 800 and 1500 mm annually.

Figure 3. Rainfall in [mm] for the city of Antananarivo. (Source: General Directorate of Meteorology, Antananarivo)

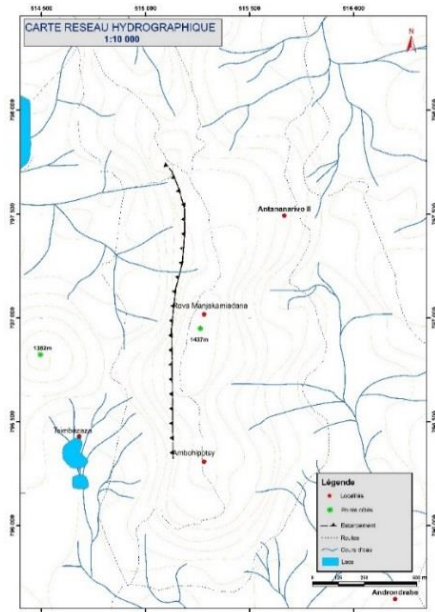
The study site belongs to the high grounds “Hauts-Plateaux” hydrological zone, presented in the following map.

Figure 4. Hydrographic network of the upper town of Antananarivo, by GIS [7].

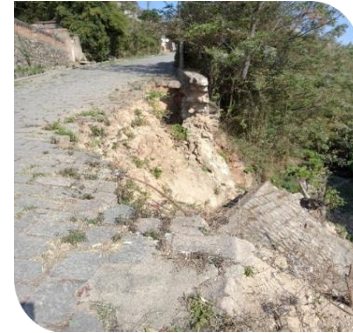
Several signs of instability were identified in the area of investigation: pull-out niches, inclination of trees, cracking of infrastructures, collapse of the retaining wall, deformation of structures and erosion of fines. These indices are signs of instability prior to landslide phenomena [7].

Figure 5: Signs of instability - triggering landslide (photo: Miraniaina Andriamalala)

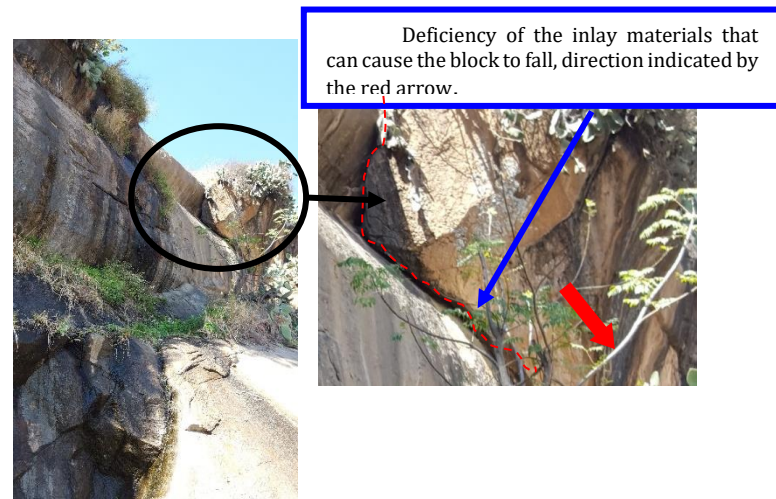
The natural evolution of cliffs and rocky slopes results in rock and boulder falls or mass landslides [5]. The characterization of morphological indices related to boulder fall phenomena is based on the identification of several parameters such as the type and size of the rock face, its slope, its geological nature, its texture as well as the unstable dihedral and boulder encrustations in the slope. Here are some clues to predict boulder falls among many others that we have observed in-situ.

Figure 6: Presence of loose blocks detachment (photos: Miraniaina Andriamalala)

The presence of unstable dihedral in the rock face is a significant indication of the "boulder fall" hazard. This index is particularly found as soon as the rock is

fractured and where there is a visible presence of water. Boulders become loose from the rock matrix, which constitutes major risks for the inhabitants in the surrounding area.

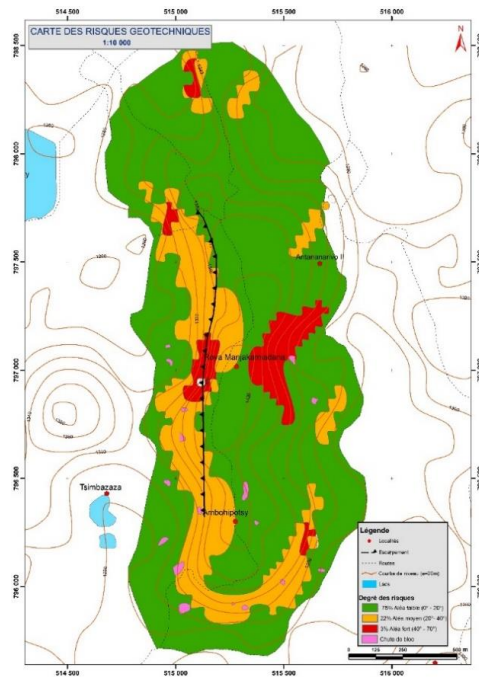
The data of the field investigations combined with the processing of the maps with ArcGIS software allows to obtain the following results: map of geotechnical risks and land use at different periods for the upper city of Antananarivo [8].

Figure 7. Geotechnical risk map of the upper city, by GIS [7]

This research shows the potentialities of combining in-situ investigation and spatial analysis (scale: 1/10 000) to estimate the landslide risk. It complements the investigations already started by other organizations.

From the different stages, the geotechnical risk and land use were identified and mapped by combining several data:

1. collection of geographical, geological, hydrological and urbanization data for the upper city of Antananarivo;
2. field investigations to record ground movement indices and carry out geotechnical tests in the laboratory;
3. aerial photography using the drones.

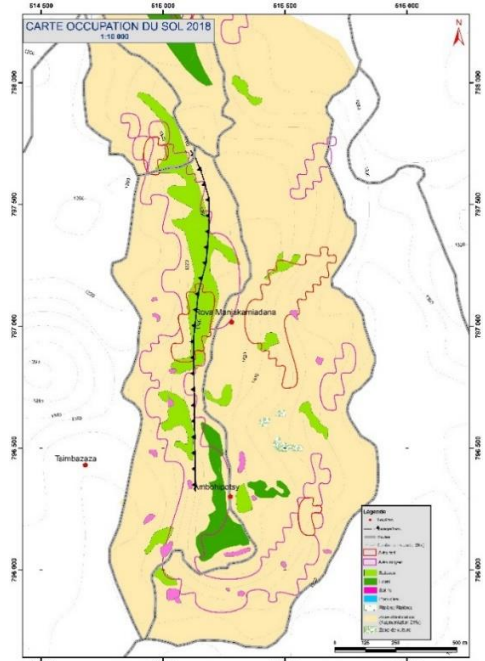
Figure 8. Land use map of the Antananarivo, by GIS [7]
