Stability Analysis of Surface and Subsurface Geological Hazards Using Numerical Approach in Hydropower Project of India- a Case Study

¹NHPC Ltd.

Parbati Hydroelectric Project-II, Nagwain, District: Mandi, Himachal Pradesh, India-175121
mainakghosh@nhpc.nic.in; nirmalsingh@nhpc.nic.in; sajan@nhpc.nic.in

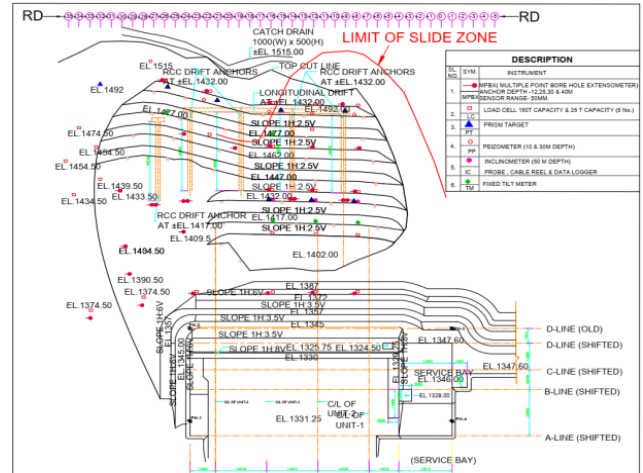
The excavation of powerhouse backslope was designed in steps of 15m with berm width of 4m as shown in Fig. 3. The excavation was initially proposed upto EL.1417M with cut line at El. 1423M with recommended support measures of 6 to 9m long, 25-36 mm dia rock anchors along with wire mesh and shotcrete. During preliminary stage of rock cutting, no sound rock mass were encountered along the cut line in the upstream portion from RD -5m to +4m due to which

Figure 3. Powerhouse excavation and instrumentation plan, NHPC [7]

To monitor the behaviour of rockmass, 6-15m long Single/Multi-point borehole extensometers were installed in the cut slopes (Fig. 3). A major jump in the instruments readings and increase in width of the cracks upto 10cm were observed before failure (Fig. 5 and Fig. 6).

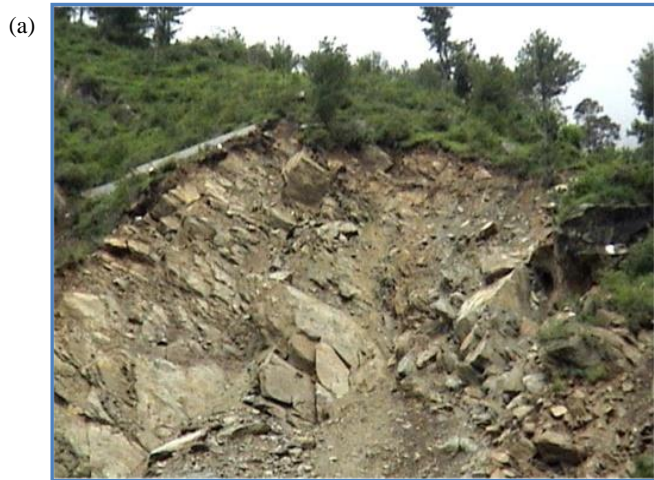
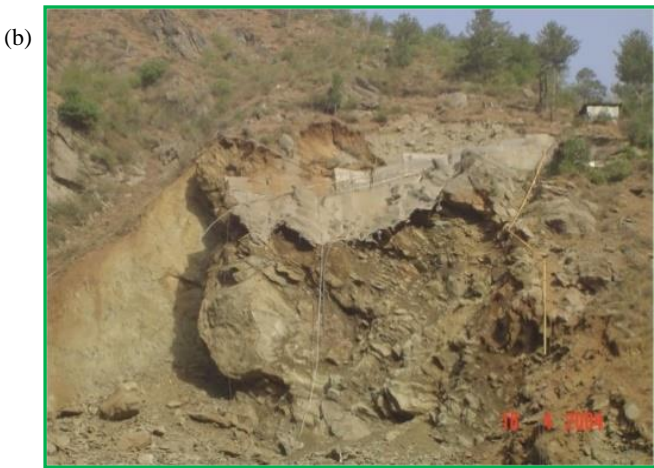
During excavation of powerhouse backslope in the service bay area between RD-7m and RD+9m, 1-50mm wide cracks started to develop at the beginning. Later on these cracks resulted into slide starting from El $\pm 1440\text{M}$ to $\pm 1368\text{M}$. This slide later on extended upto El $\pm 1480\text{M}$. Prior to failure, heavy rainfall further triggered rotational movement of rockmass along the weak plane (Fig. 4a). Slumped rockmass along with valley dipping joints with low shear strength vis-à-vis heavy precipitation culminated into slip circle failure and caused major slide in the service bay area (Fig. 4b).

Figure 4 a,b. View of slide in the u/s of powerhouse cut slope between RD -7m and +9m starting from El±1440M to El±1368M

Restoration of the slope was carried out by slope dressing, wire meshing, installation of 6m and 9m long rock anchors, 25mm dia and 6m long soil nail and 150mm thick shotcrete in two layers. Drainage/pressure relief holes of length 3-4 m were also provided. The estimated amount of slided muck was around $30,000\text{m}^3$ to $35,000\text{m}^3$.

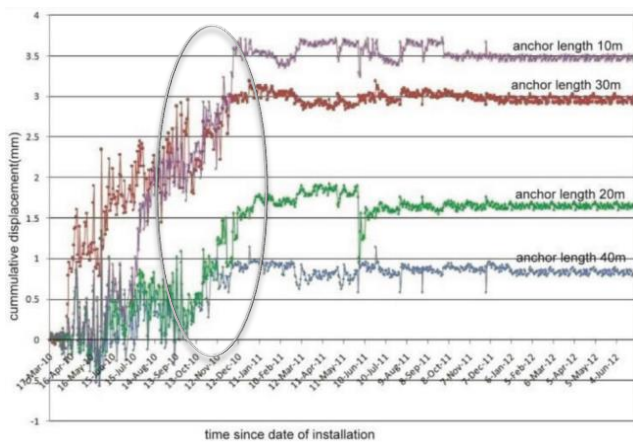
Figure 5. Cumulative displacement readings in MPBX, Bhatnagar and Das [8]

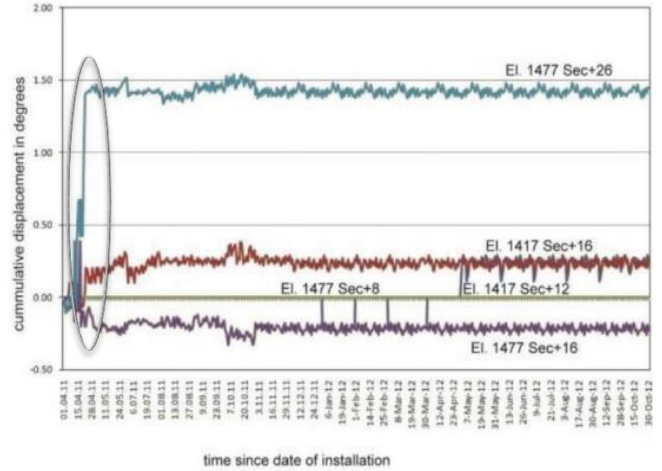
Figure 6. Cumulative displacement readings in Tiltmeter [8]

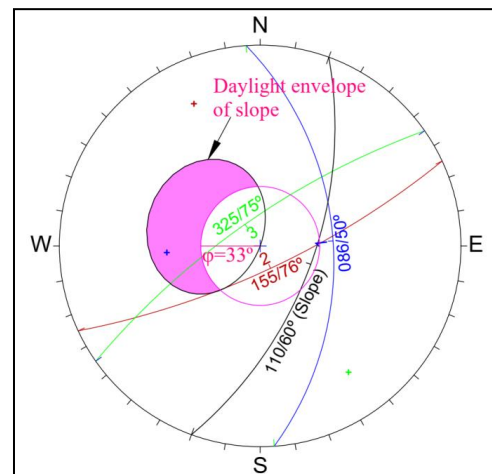
a) For planar failure, plane on which sliding occurs should strike subparallel to the slope face, pole of the sliding plane should fall within the daylight envelope of the slope and dip of the slope must be greater than the dip of the sliding plane as shown in Fig. 7.

Taking above factors into consideration, it is found from Fig. 7 and Fig. 8 that the backslope of powerhouse is susceptible to planar failure along the foliation joint ($086^{\circ}/50^{\circ}$) and wedge failure due to intersection of J-1 ($086^{\circ}/50^{\circ}$) and J-2 ($155^{\circ}/76^{\circ}$) joint sets.

Figure 7. Stereographic projection for planar failure

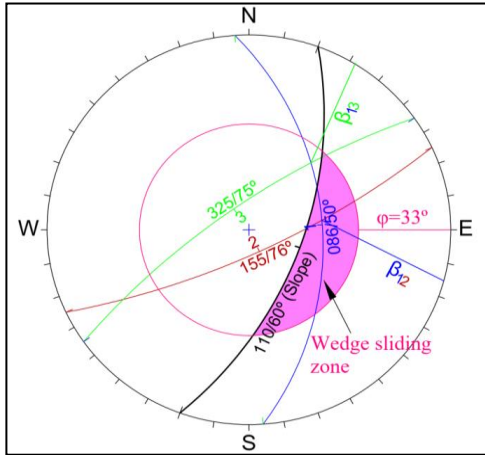
b) For wedge failure, the spherical triangle must fall within the friction cone ϕ for potentially unstable wedges and intersection of joint planes should fall within the wedge sliding zone formed by the intersection of slope and friction cone (Fig. 8).

Figure 8. Stereographic projection for wedge failure

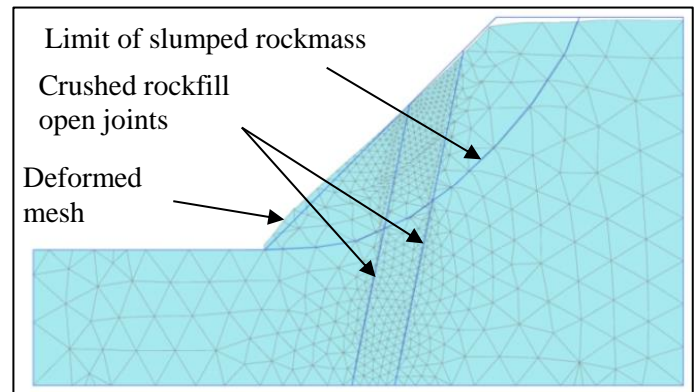
To carry out slope stability analysis, a two dimensional finite element model of the unsupported slope was created using Finite Element model (FEM) Plaxis 2D ver.8 [11]. An unsupported excavation of the cut slope will cause the instability of the rock slope. The geometry of the natural sloping ground wherein the cut slope was excavated is considered to be metabasics bedrock with slumped rockmass upto a depth of 20m alongwith open joints extending upto the entire height of the slope as shown in Fig. 11.

Figure 11. Mesh generation showing deformed mesh

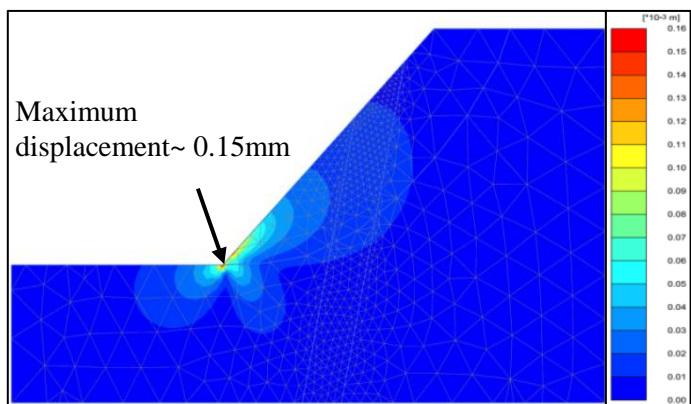
Figure 12. Total displacement maximum at the toe of the slope

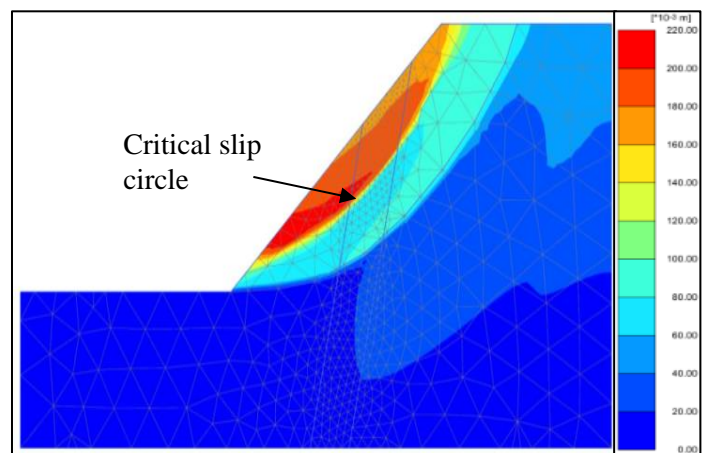
when it is desired to calculate global factor of safety for a given situation. Therefore, ϕ - c reduction process is also adopted for calculating FoS. Critical slope angle is the key factor in the slope failure analysis. The deformation of mesh shown in Fig. 11 is maximum at the toe as shown in Fig. 12, since the toe is under heavy strain and is always vulnerable in a steep and large slope. The displacement of the toe of the slope leads to the formation of a failure zone as shown in Fig. 13. Maximum displacement at toe calculated by the model is 0.15mm. Total probable displacement of the slope due to toe deformation is calculated as 200-220mm (Fig. 13). The mode of failure of the slope is circular and critical depth of the failure zone is around 10m.

Figure 13. Critical slip circle showing the failure plane

models indicate development of critical slip circle of failure at a depth of 10-15m as shown in Fig. 13 and Fig. 17. FoS values calculated from both LEM and FEM analysis are lower than the desired factor of safety and indicate unstable slope condition. The fundamental reason which explains the difference in computed FoS by FEM and LEM is that LEM depends on static force or moment equilibrium whereas FEM is based on stress-strain relationship which can accommodate change in stress. Moreover, FEM considers elastic parameters such as Young's modulus and Poisson's ratio in their material properties and lay more emphasis on the geometry of the slope whereas LEM considers uniaxial compressive strength of the rock, disturbance factors like blasting damage during slope excavation and also

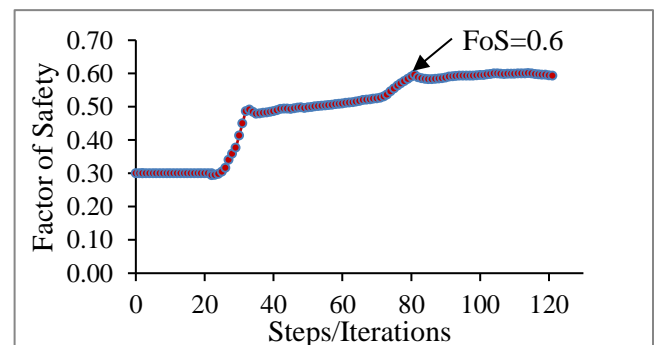
FoS of the slope as calculated by the model is 0.6 after 120 iterations as shown in the graph in Fig. 14. Fig. 15 shows the accumulation of maximum principal strain which commensurate with the depth of slip circle. The principal strain is concentrated more at the middle of the slope due to the presence of crushed rock filled valley dipping open joints of weak strength and forms a circular zone of failure.

Figure 14. Calculated FoS by the model after 120 iterations

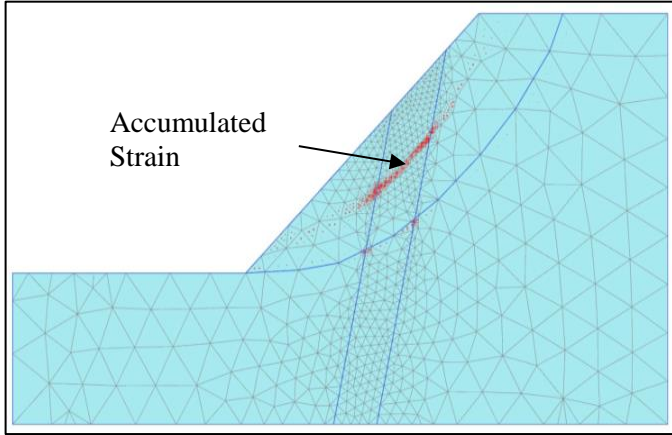
Figure 15. Maximum principal strain at the middle of slope due to valley dipping joints of low shear strength.

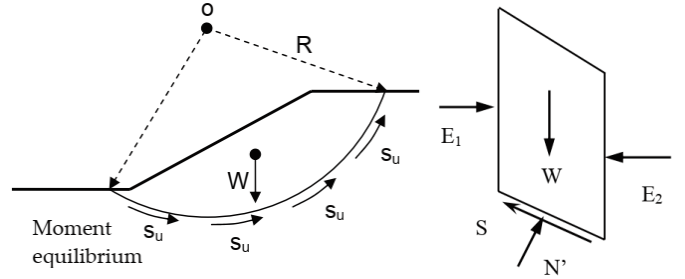
The advantage of using BS method is that it considers the interslice normal forces, E as shown in Fig. 16 and the equation for FoS hence become non-linear. However, it neglects the interslice shear forces. FoS is calculated for circular shear surface using the following equation:

Figure 16. Bishop's simplified method for calculating FoS, Abramson et al. [14]

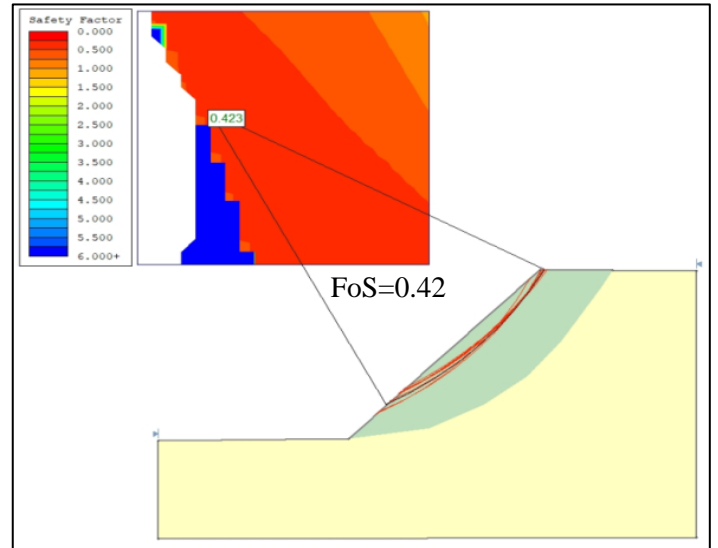
The deterministic factor of safety and critical slip circles are shown in Fig. 17. Comparison of FoS values determined from FEM and LEM shows that both the

Figure 17. Critical slip circle and calculated FoS determined by Slide

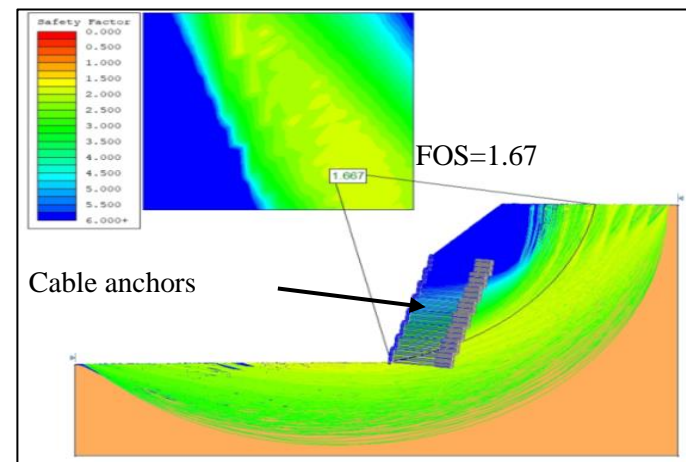
Back analysis was carried out with the cable anchor support in the backslope of the powerhouse by LEM and the result shows that FoS increased considerably upto 1.7 as shown in Fig. 18. Thus installation of cable anchors restricted the movement of the slumped rockmass leading to the stabilization of backslope which was also reaffirmed by various instrumentation readings installed in the powerhouse backslope. In addition, four number of drifts were excavated to carry out grouting of the open joints as shown in Fig. 3. The drifts were reinforced with steel and concrete up to crown to bear the induced stresses imparted by the rock cover.

Figure 18. LEM analysis showing increase in FoS value after installation of cable anchors

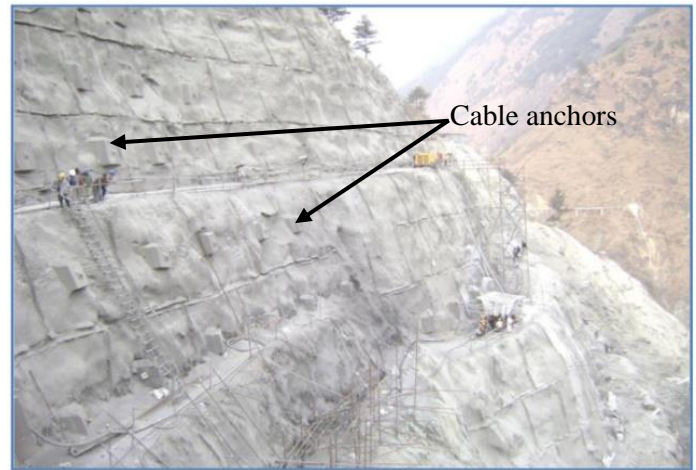
As per the support analysis, cable anchors of length 35m were provided in the cutslope above each benches as shown in Fig. 19. The fixed and free length of the cable anchors are 9m and 26m respectively. The

fixed 9m length at the end of cable anchor was fully grouted in the beginning and stressing was done for checking the performance of grout/fixed length.

Figure 19. Backslope stabilization by cable anchors

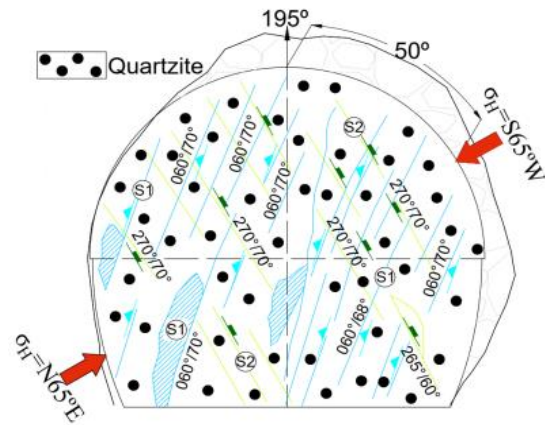
Based on the world stress map [16], it is found that in the study area, the direction of in-situ vertical and horizontal stresses ($S_{65^\circ W}$) are oriented subparallel to the major joint set ($270^\circ/70^\circ$) and at high angle (50°) with the tunnel alignment ($N195^\circ$) as shown in Fig. 20.

Figure 20. Geological face log of HRT showing principal stress direction, σ_H

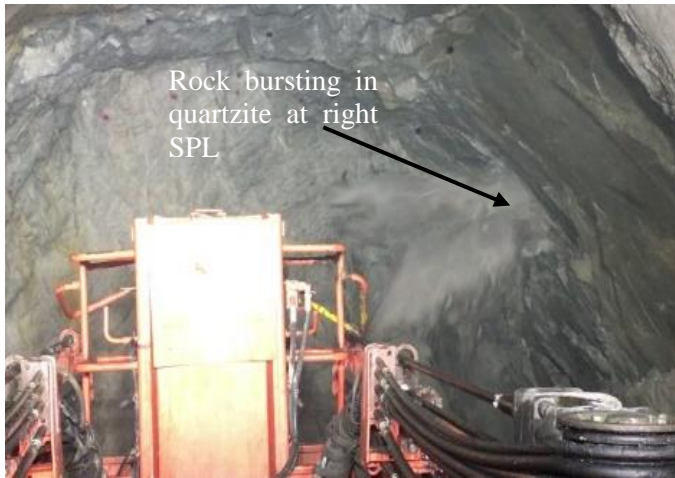
On the basis of rock bursting events experienced during excavation in quartzite rockmass in head race tunnel (HRT) of Parbati hydroelectric project-II as shown in Fig. 21, back analysis of magnitude of in-situ stresses in rock bursting zones was carried out using FEM software Phase 2, v.8.0 [18] to determine the role of strength, elastic properties of the rockmass and field stress ratio in causing rock bursting.

Figure 21. Rock bursting in right springline (SPL) area of HRT

Drilling of stress relief holes of 76mm dia at face, application of 100-150mm thick steel fibre reinforced shotcrete along tunnel profile and installation of long rock anchors in crown and wall at smaller spacing were the rock support installed in the tunnel to negotiate rock bursting conditions.

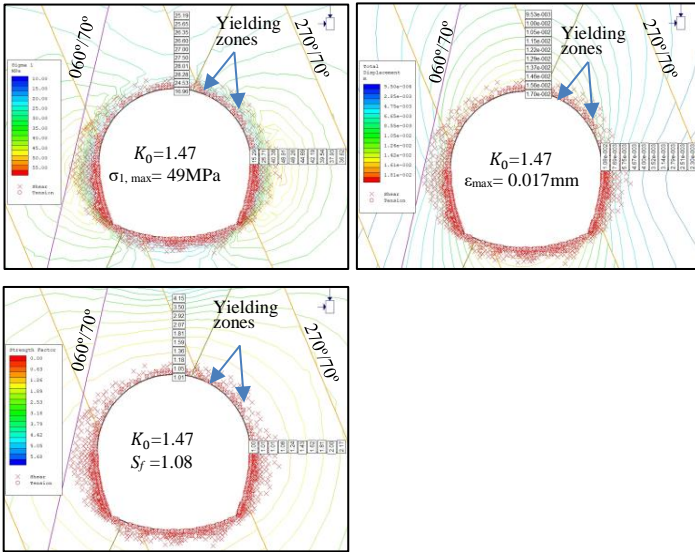
From Fig. 22 & Fig. 23, it can be interpreted that with decrease in field stress ratio, K_0 or with increase in in-situ stresses, σ_V and σ_H due to increase in depth of overburden, the values of principal stress, σ_1 and deformation, ϵ increase leading to the decrease in strength factor, S_f (<1.5) in both the crown and spring line area of the tunnel. The magnitude of the principal stress, σ_1 increases upto 1.75 times after excavation under both the minimum and maximum overburden cover as determined from the numerical modelling and shown in Fig. 24. The yielding due to shear also concentrates more at lower field stress ($K_0=0.97$) while the yielding due to tension concentrates more in the area of intersection of the strike of the major joints with the tunnel axis (Fig. 22 & 23).

Figure 22. Stress contours showing Principal stress (σ_1), displacement (ϵ) and strength factor (S_f) values at crown for stress ratio $K_0=1.47$ in study area

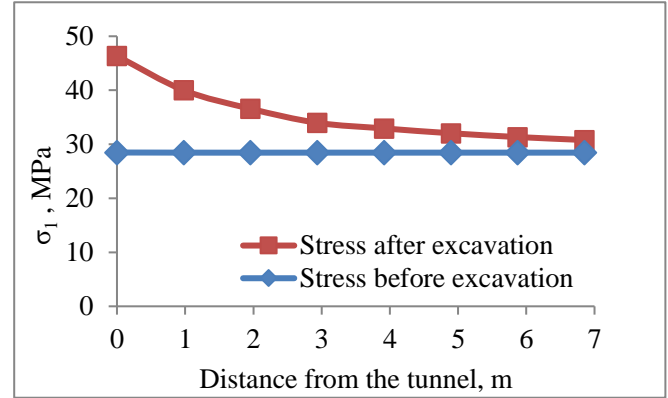
Figure 24. Stress magnitude before and after excavation under rock bursting conditions in the study area

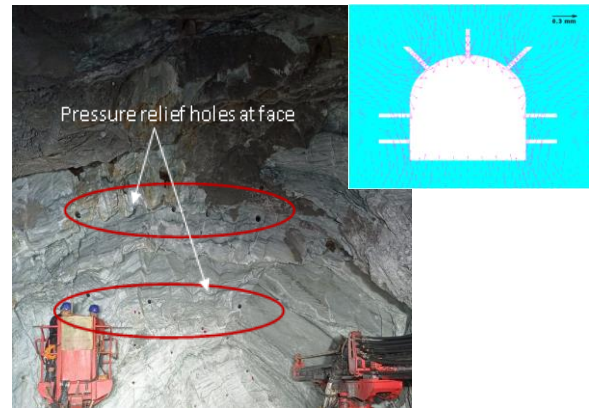
Stress relief holes release the accumulated elastic strain energy and convert radial stress into tangential stress as shown in Fig. 25. It also transfers the high stresses to the deeper surrounding rock, thus reducing

Figure 25. Drilling of stress relief holes in the tunnel of the study area to reduce rock bursting; (Inset) stress relief holes converting radial stress to tangential stress

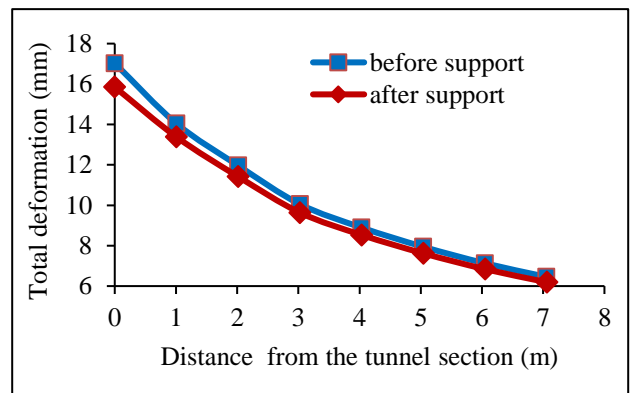
the intensity of bursting. The position and orientation of stress relief holes were improvised depending on the direction of stress release. Shotcrete has higher ductility than backfill concrete and is thus a more effective support measure than rigid rib support in rock bursting conditions. The above installed support measures effectively decrease total deformations due to rock bursting in quartzite as shown in Fig. 26.

Figure 26. Deformation magnitude before and after installation of support in the study area
