Experimental Study on Inspector Attributes Influencing Crack Detection in Steel Bridge Visual Inspections

Kouichi Takeya¹, Aya Watanabe², Yuichi Ito³, Eiichi Sasaki¹

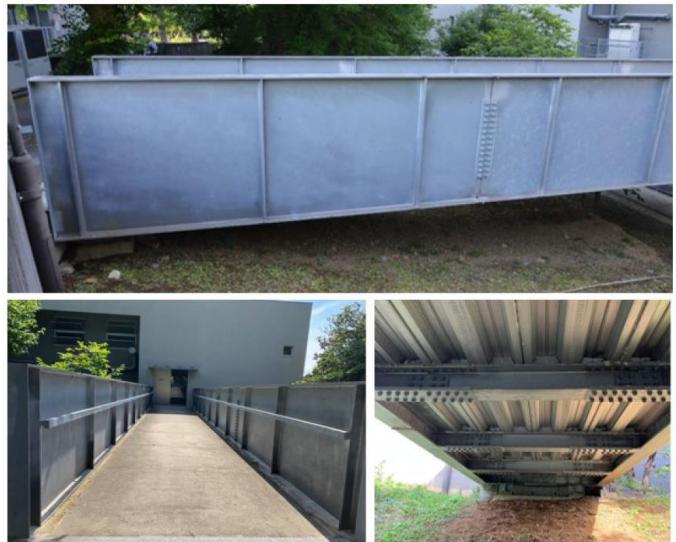
The visual inspection experiment was conducted on a pedestrian bridge located at the entrance of a building in the Institute of Science Tokyo, as shown in Figure 1. The bridge features two welded girders composed of flanges and webs joined by longitudinal fillet welds. While these joints were designed with fatigue category D and defined according to JSSC guidelines (two million cycles, 100 MPa) [6], some other joints fall below this level and are therefore considered vulnerable for road or railway bridge applications. Nonetheless, it is important to note that a lower fatigue category does not inherently indicate weakness as structural vulnerability depends on the balance between the fatigue strength and the actual stress acting on a joint.

Figure 1. Overview of the test bridge used for the visual inspection experiment.

This pedestrian bridge was originally designed without specific consideration of fatigue. Due to its structural configuration, both the upper and lower girders are accessible and visible, making it suitable for hands-on visual inspection. The visual inspection experiment was carried out under the assumption that car or train loads pass over the deck slab.

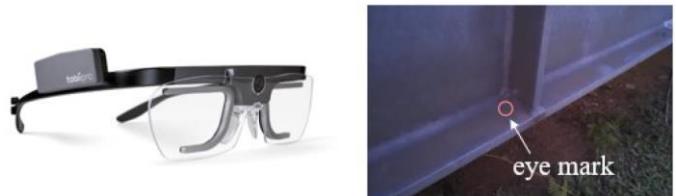
Figure 2. Eye-tracking device used during inspection.

Eye-tracking data was recorded using the wearable device (Tobii Pro Glass 2) as shown in Figure 2. This device employs the corneal reflectometry method to detect eye movement and overlays eye marks onto a video recording of the inspector's visual field. The device also records voice through a built-in microphone. Additionally, two portable cameras were used to record inspector movements with a frame rate of 25 fps.

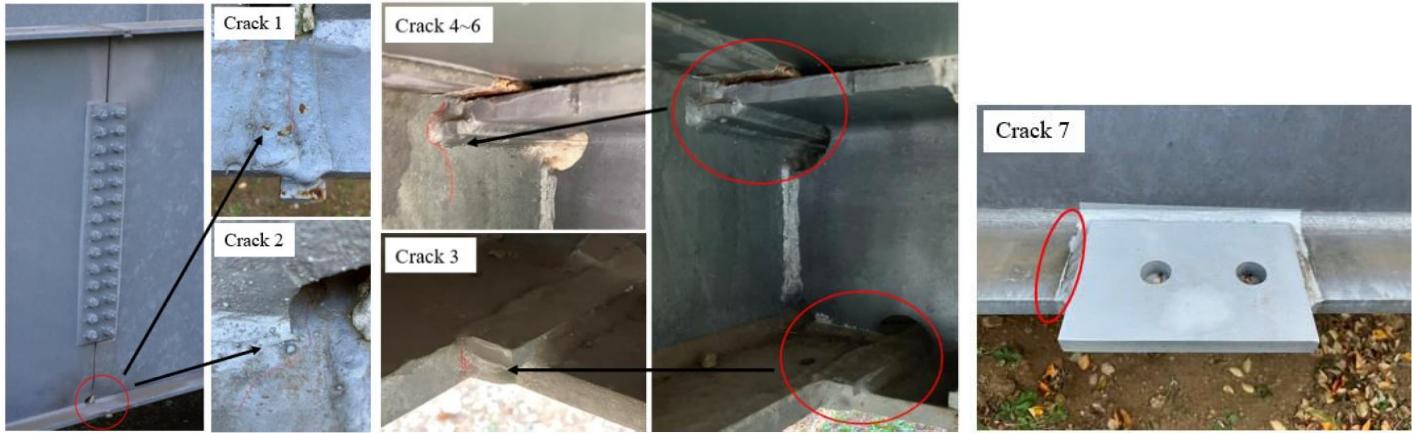
The setup of simulated cracks is summarized in Table 1. The fatigue categories are defined according to the JSSC guidelines [5]. Seven structural joints with high susceptibility to fatigue crack initiation were selected. The simulated fatigue cracks were drawn using a red

pencil as shown in Figure 3. In actual bridge inspections, fatigue cracks are often accompanied by coating cracks or rust stains that appear reddish due to corrosion products. The simulated cracks were designed to be 30 mm or longer, representing cracks that have already propagated to a visually detectable stage. This setup focuses on evaluating inspectors' ability to recognize visible fatigue damage, rather than their capacity to identify microcracks that require magnified inspection techniques.

Figure 3. Simulated cracks drawn on structural joints of the test bridge.

Cracks 4 to 6 were intentionally identical in type to help determine whether inspectors would inspect similar locations after identifying a crack. Crack 7 was added to simulate fatigue in a joint not subjected to external forces, where a steel plate was attached to the lower flange and joined using a silicone-based impression material. Moreover, an inspector's focus on atypical structural features was analyzed to quantify their understanding of standard road and railway bridge design (Figure 4 and Table 2). The time spent gazing at each point served as an indicator of structural awareness.

Table 1. List of simulated cracks and their locations set on the test bridge.

Crack location	Crack length	Fatigue category [5]
Crack 1	On-site joint of main girders	Lower flange horizontal butt weld	38 mm
Crack 2		Web scalloped section	76 mm
Crack 3	Joint between the main and horizontal girders	Lower flange in-plane gusset weld joint	< H
Crack 4		73 mm	< G
Crack 5	Web out-of-plane gusset weld joint	55 mm	< G
Crack 6		72 mm	< G
Crack 7	Welds of the main girder	Lower flange attachment	30 mm

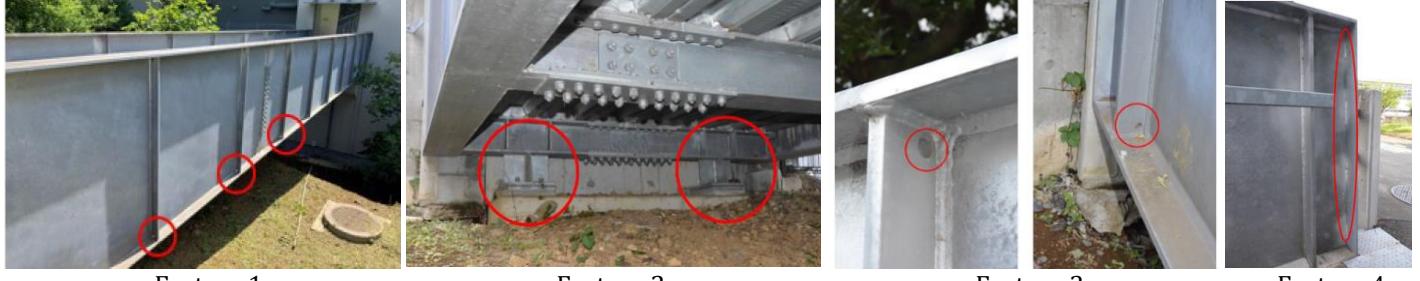
Figure 4. Examples of atypical structural features identified on the test bridge.

Table 2. List of atypical structural features evaluated during inspection and their fatigue-related characteristics.

Structural location or description	Fatigue category [5]
Feature 1	Welding at the bottom end of the intermediate vertical stiffeners	E
Feature 2	Bearing supports transverse girder	-
Feature 3	Scallop-like holes at both top and bottom ends of the intermediate vertical stiffeners	-
Feature 4	Steel plates at girder ends connected by intermittent welds	-
Feature 5	Thickness irregularity of flanges and stiffeners	-
Feature 6	Combined welded and bolted joints in the main girders	-
Feature 7	Welded attachments on the lower flange of the main girders	I

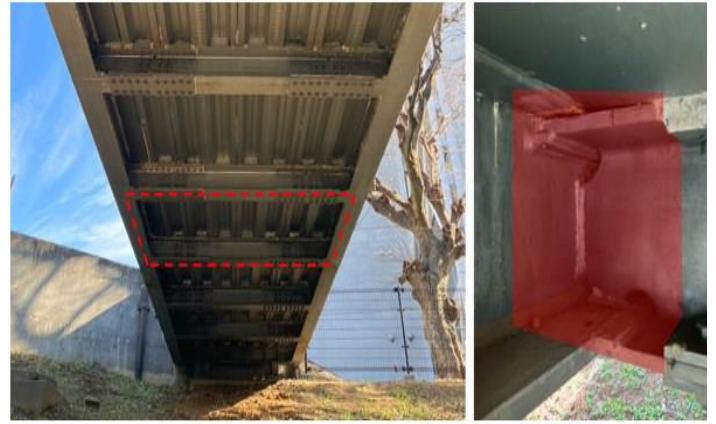
To analyze where inspectors focused during weld line inspection, a rectangular frame was defined as shown in Figure 5. Since fatigue cracks are most likely to occur at the start and end of weld lines, the proportion of time spent inspecting these regions was computed relative to the total time spent within their respective rectangular frame. These start/end points were defined as the areas containing in-plane gussets and their surrounding regions. A longer gaze focused on these points was interpreted as a deeper understanding of fatigue-prone areas and more efficient inspection behavior.

Figure 5. Defined gaze area on the backside weld lines for analysis of attention to start/end points.

The inspectors who gazed the longer at the start and end points were mainly in Group 1 and Group 2. Those who paid less attention to the start and end ends mainly focused on the center of the weld line and the bolted joints.

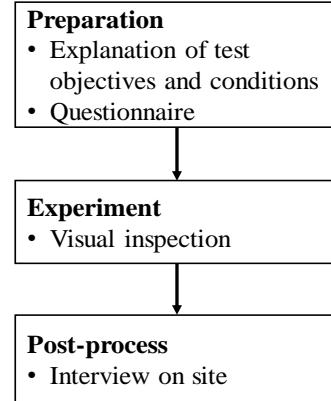
The experiment procedure has been summarized in Figure 6. First, a pre-survey was administered to collect background information and classify inspectors according to their experience and expertise. Second, each inspector performed a visual inspection within a maximum time limit of 20 minutes. Soon after the visual inspection, post-experiment interviews were conducted to clarify the intent behind certain gazing behaviors and related crack detection. Based on these interviews, simulated crack detection was categorized according to reasons specified by the inspectors. Likewise, focus on atypical structural features was classified based on perceived discomfort or irregularity.

Figure 6. Flowchart of the experimental procedure.

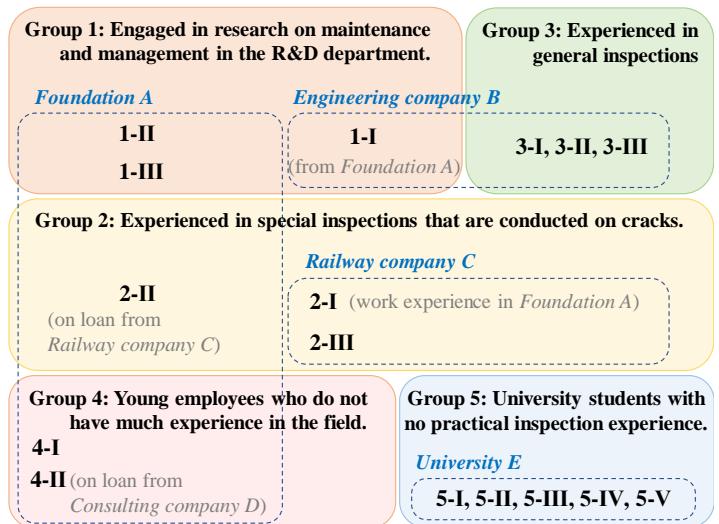
Prior to the inspection, 15 participants completed a questionnaire regarding both their work and inspection experience. Based on this information, they were classified into five groups as shown in Figure 7. Group 1 consists of three inspectors (1-I, 1-II, 1-III) who have been engaged in research on maintenance and management in a research and development (R&D) institute specializing in railway technology, and who possess extensive experience in the formulation of inspection and design standards. Group 2 consists of three inspectors (2-I, 2-II, 2-III) who possess mainly onsite field experience and more specifically, experience in special inspections of cracks. One of them has been in the R&D department on secondment. Group 3 inspectors are also mainly experienced in the field, but usually perform only general inspections (3-I, 3-II, 3-III). Group 4 consists of two younger employees who do not have much experience in the field: 4-I has some experience in individual inspections where detailed inspections are performed after cracks are found. 4-II only has experience in design and has never performed inspections. Group 5 consists of five university students (5-I to 5-V), including master's and undergraduate students in civil engineering, with no practical inspection experience.

Figure 7. Grouping of inspectors.
